BIG FOUR MINE DAM

WASHINGTON COUNTY, MISSOURI

MO 30729

PHASE 1 INSPECTION REPORT NATIONAL DAM SAFETY INSPECTION

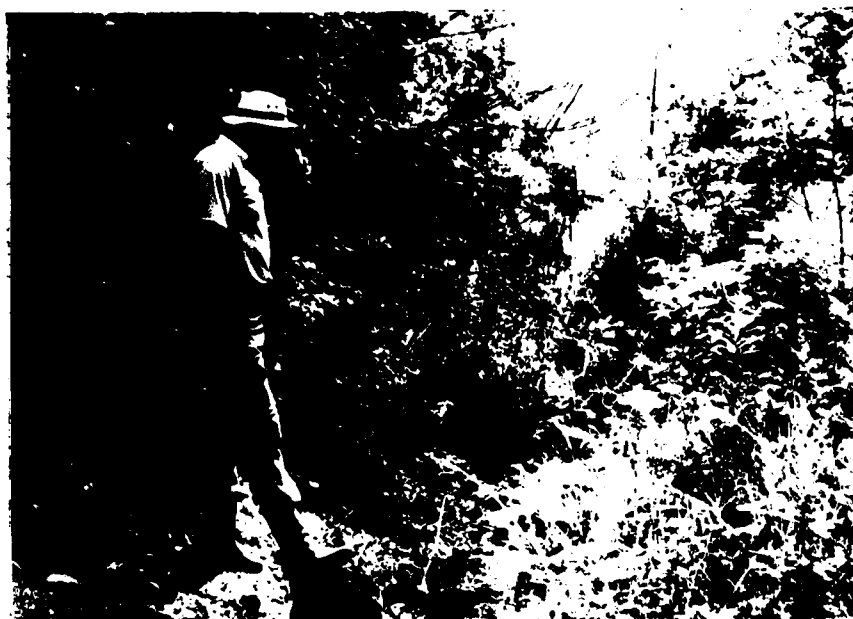
8. Discharge channel near maximum dam section. Flow is from seepage. Observer is standing on dam toe.
